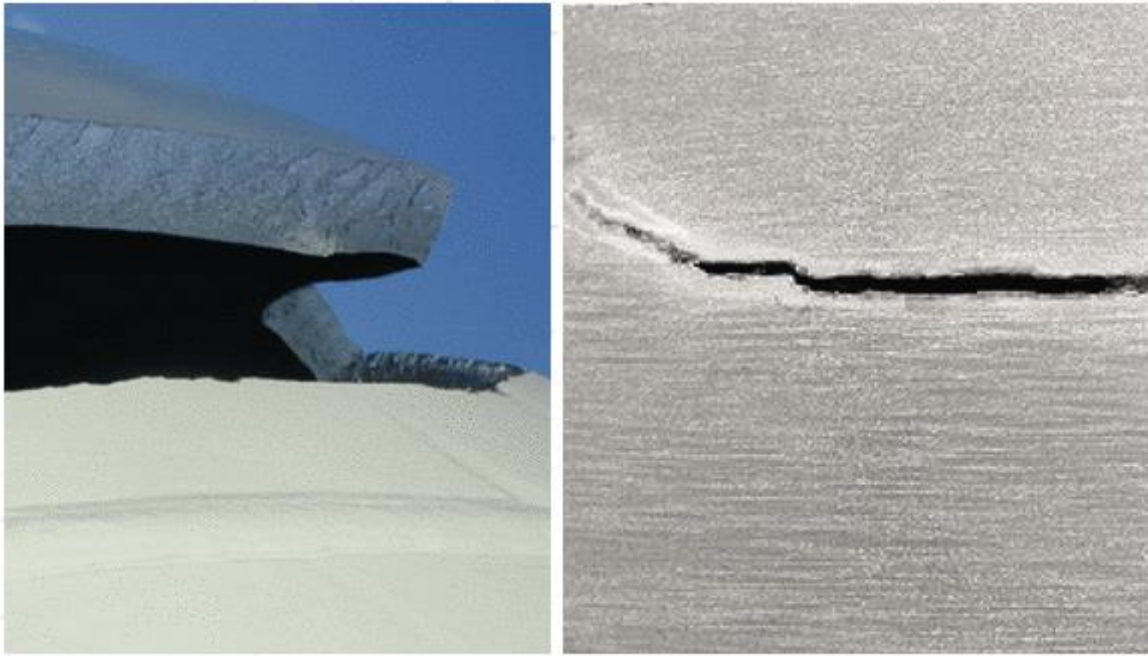
Damage mechanism: Brittle Fracture. Damage mode: Failure mode: Rupture. CC Caroline Phoenix

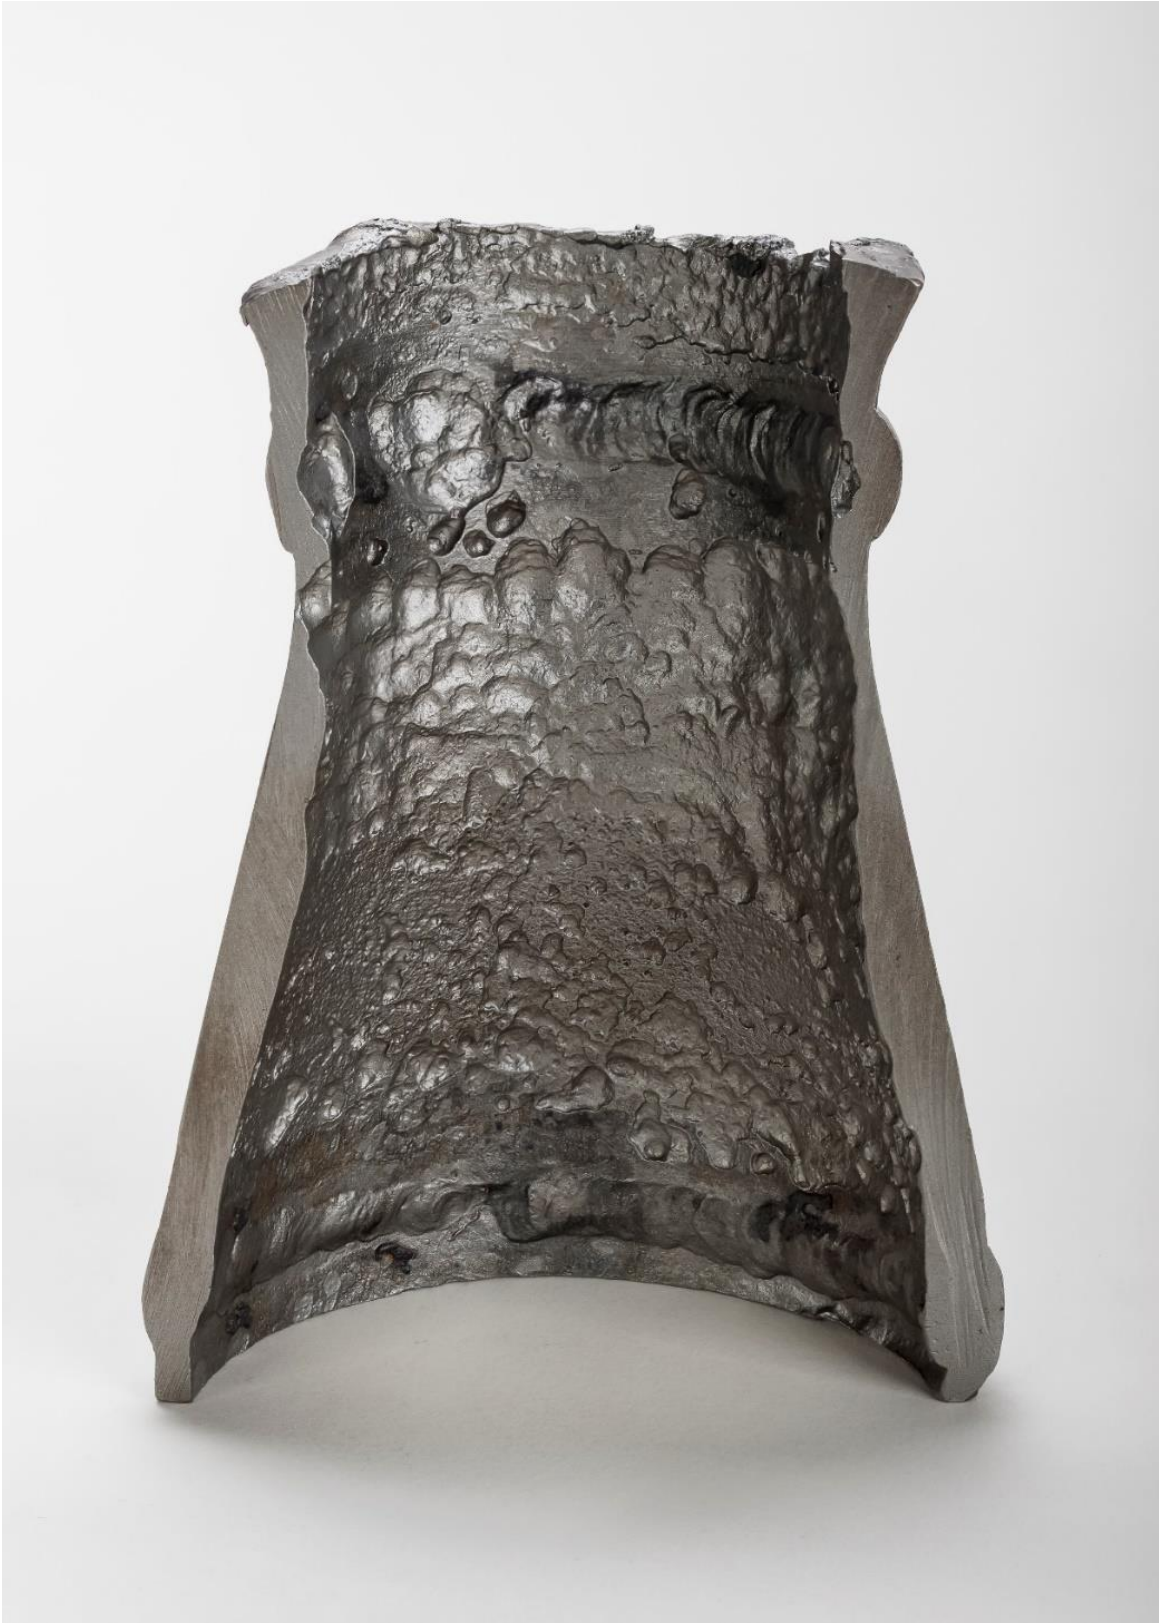
Damage Mechanism: Sulfolane corrosion in a pipe reducer. Damage mode: general thinning. ©  
CEphoto, Uwe Aranas

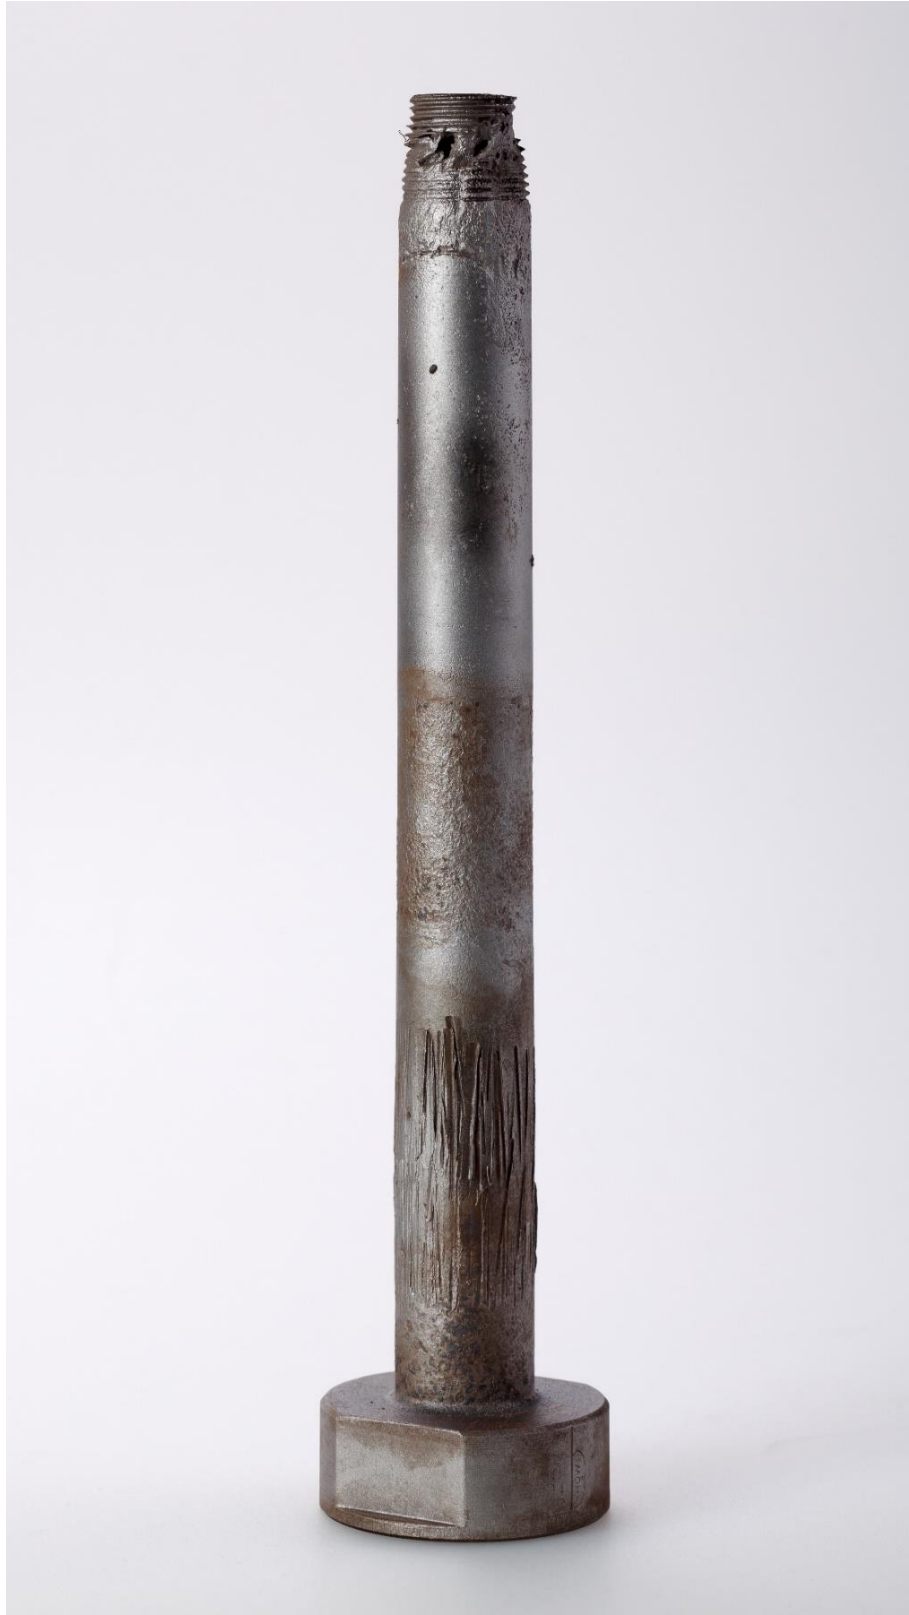
Corrosion and erosion at a steam nozzle © CEphoto, Uwe Aranas

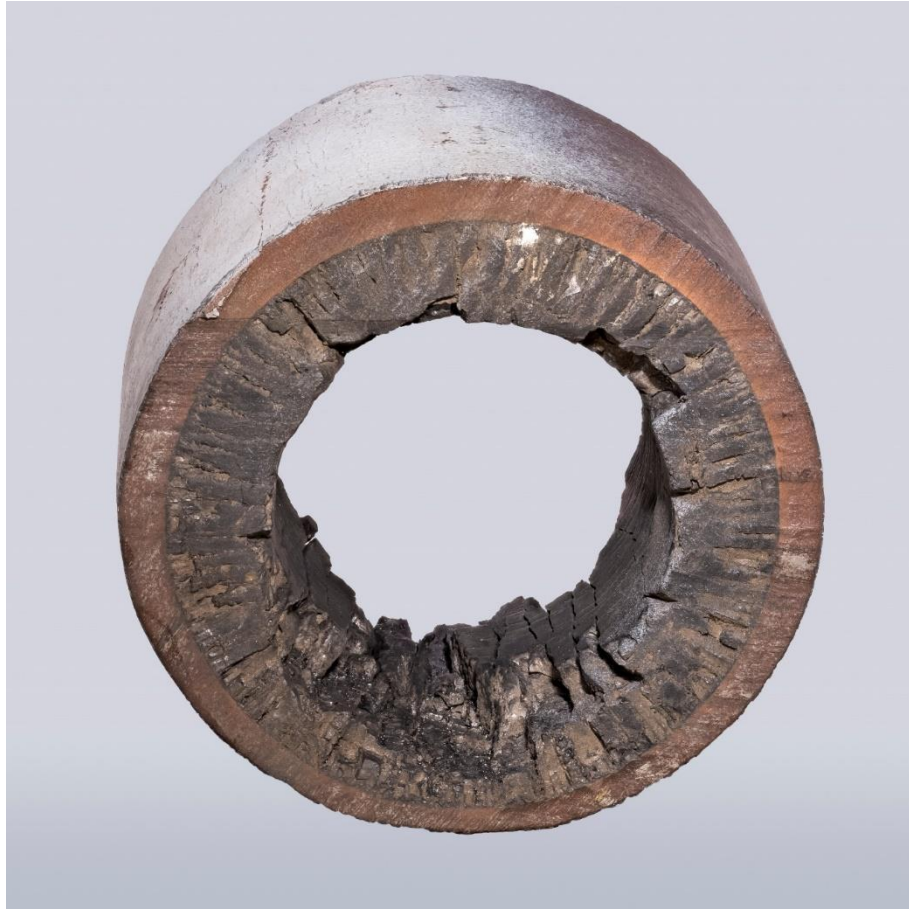
Scaling and Cracking of a 12CrMo19-5 tube © CEphoto, Uwe Aranas

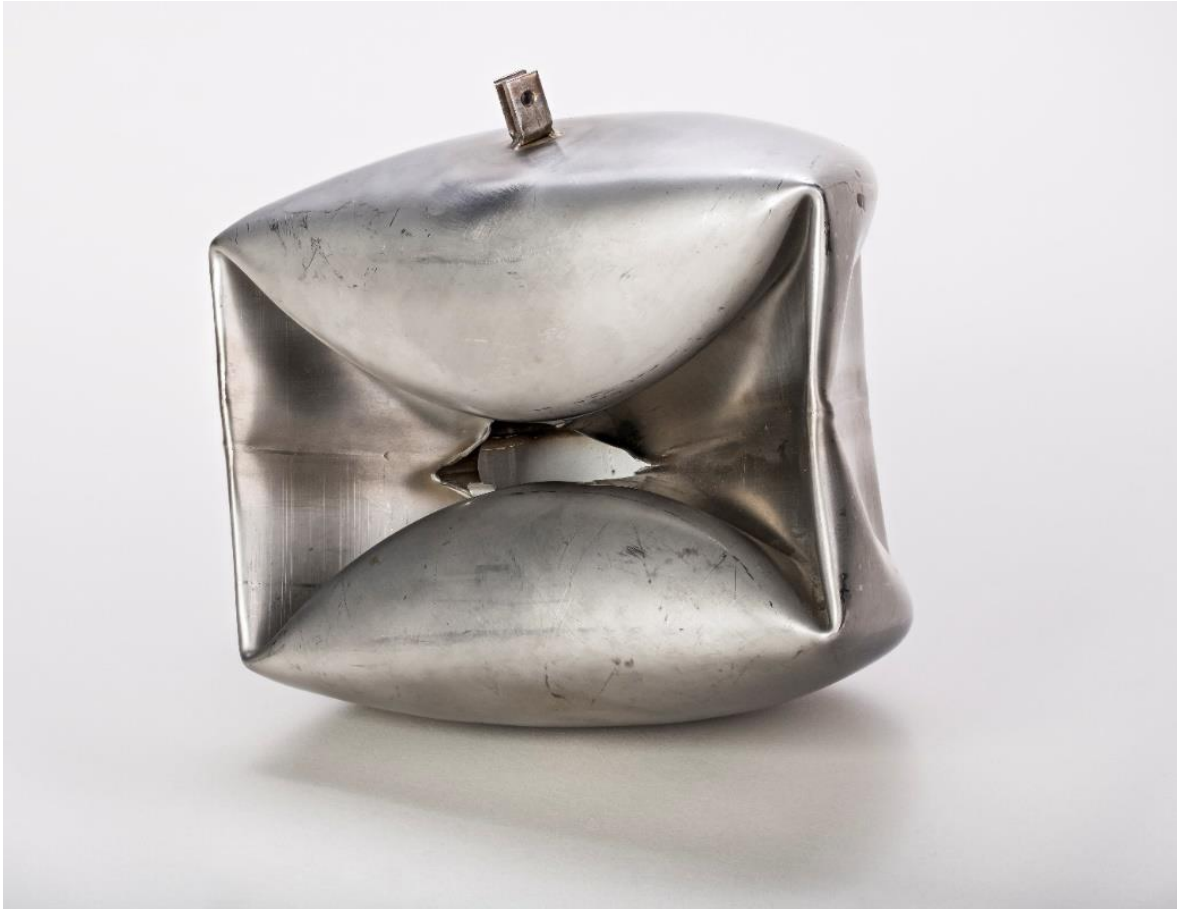
A float gauge of a separation vessel, destroyed by a Joukowski Pressure Shock from an interconnected fluid pipeline. The pressure shock squeezed the symmetric float gauge until it burst as consequence of the external overpressure © **CEphoto, Uwe Aranas**

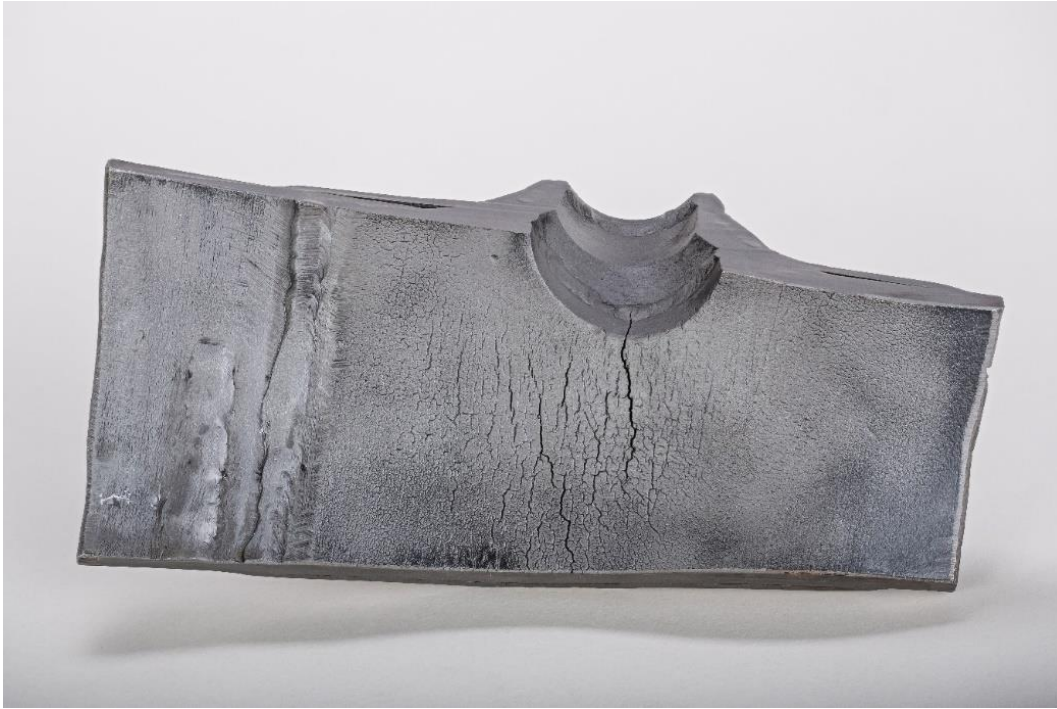
Damage mechanism: Stress corrosion cracking, caused by tension in an unsuitable welded reinforcement collar. No failure present © CEphoto, Uwe Aranas

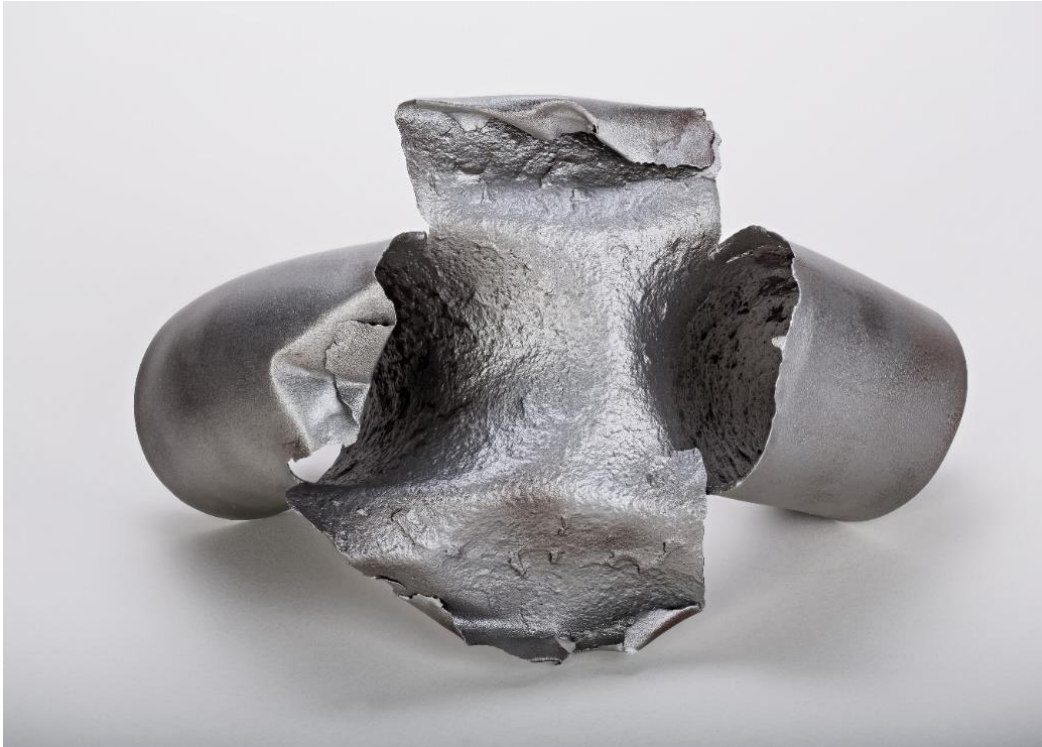
36 bar steam pipeline of a soot blowing system, the pipe bend burst as a consequence of internal erosion. Material: 15 Mo 3 (steel) © **CEphoto, Uwe Aranas**

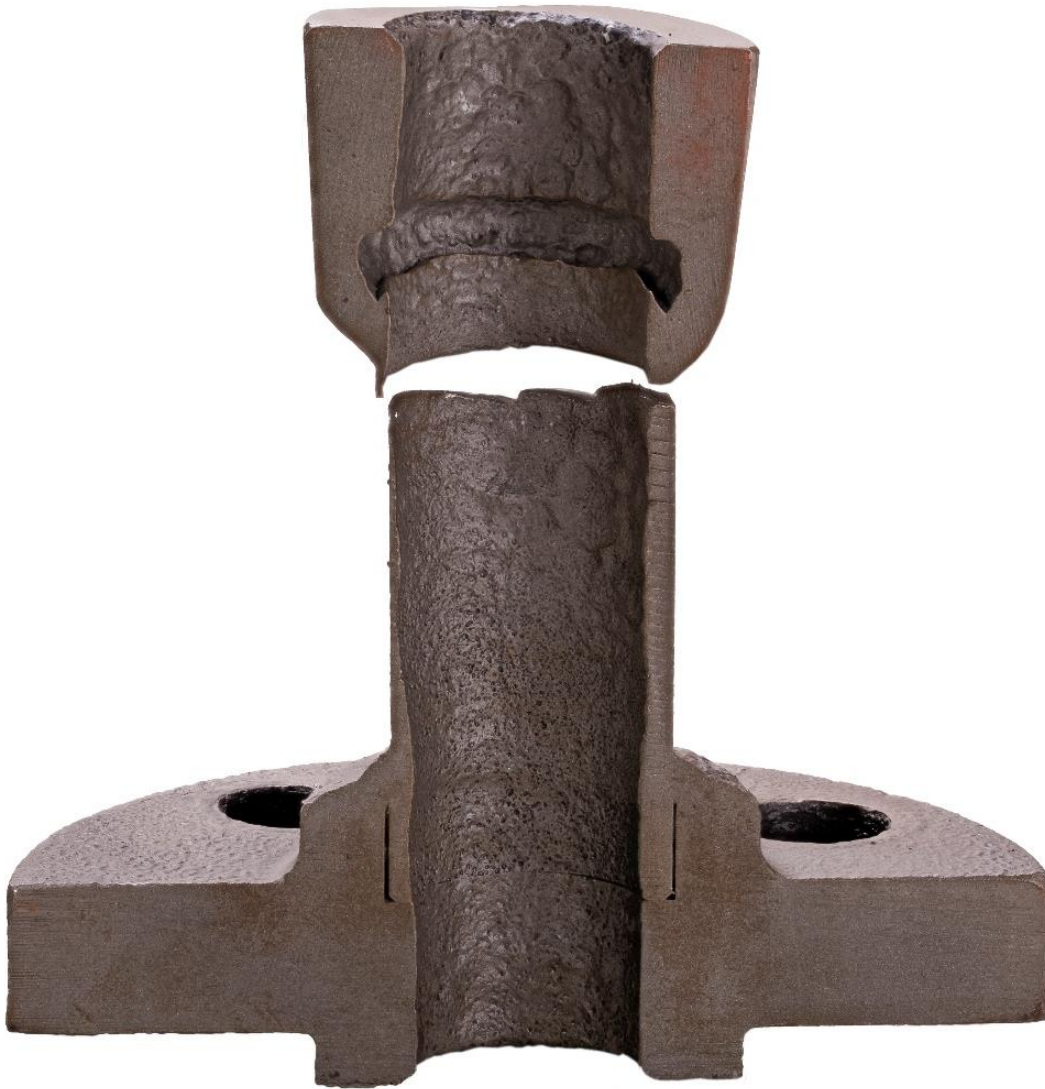
Damage mechanism: High-temperature sulfur corrosion of a 12 CrMo 19.5 pipe stub (used for insertion of a pressure indicator) © CEphoto, Uwe Aranas

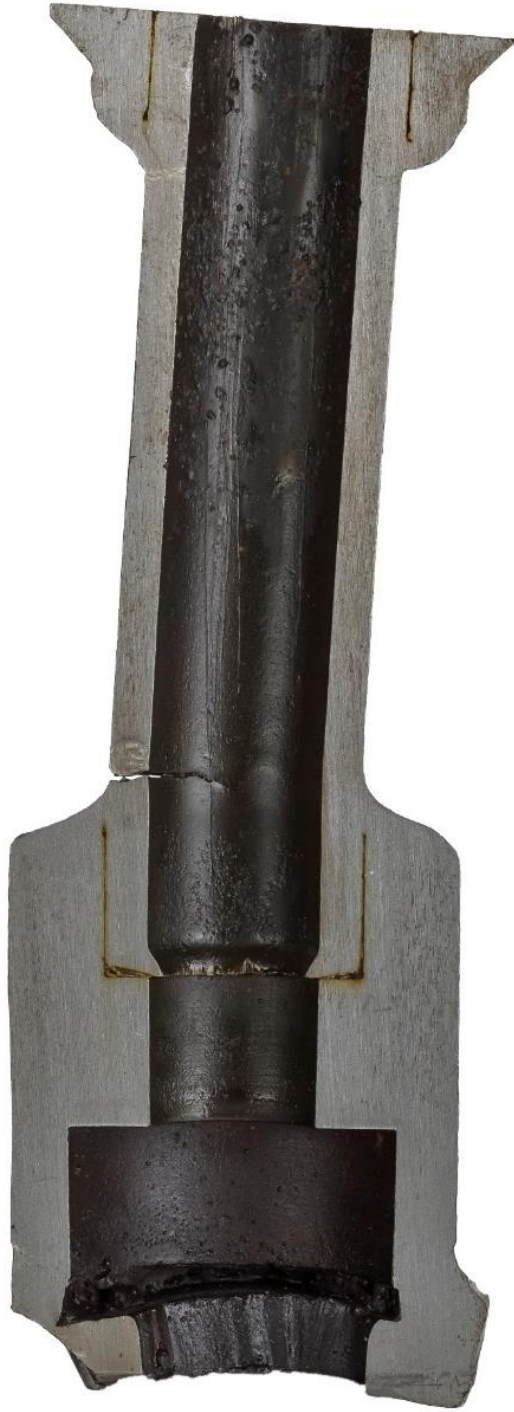
Fatigue fracture of a PI nozzle © CEphoto, Uwe Aranas

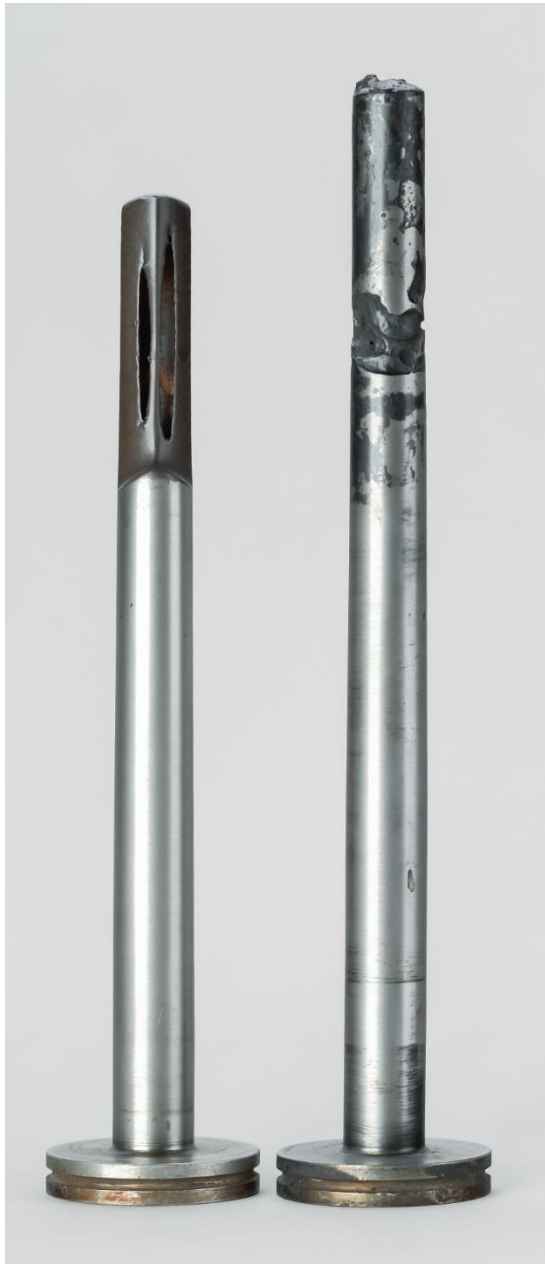
Different types of degradation of thermowells with considerable material loss due to erosion and corrosion attacks © **CEphoto, Uwe Aranas**

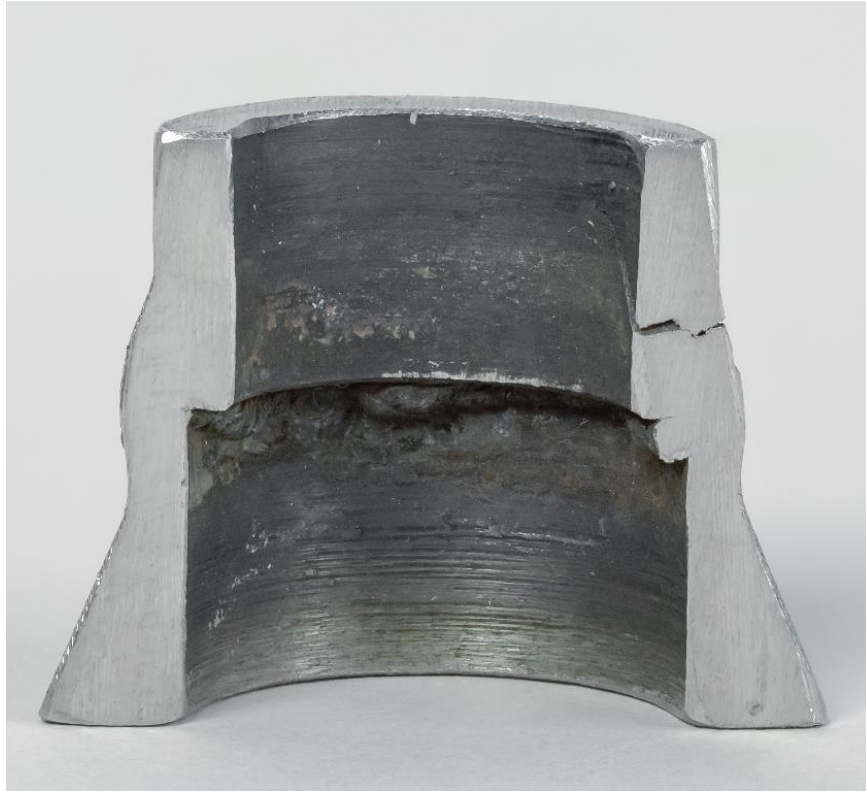
Damage Mechanism: Stress corrosion cracking of a quench pipe. Material: 1.4541 © CEphoto, Uwe Aranas

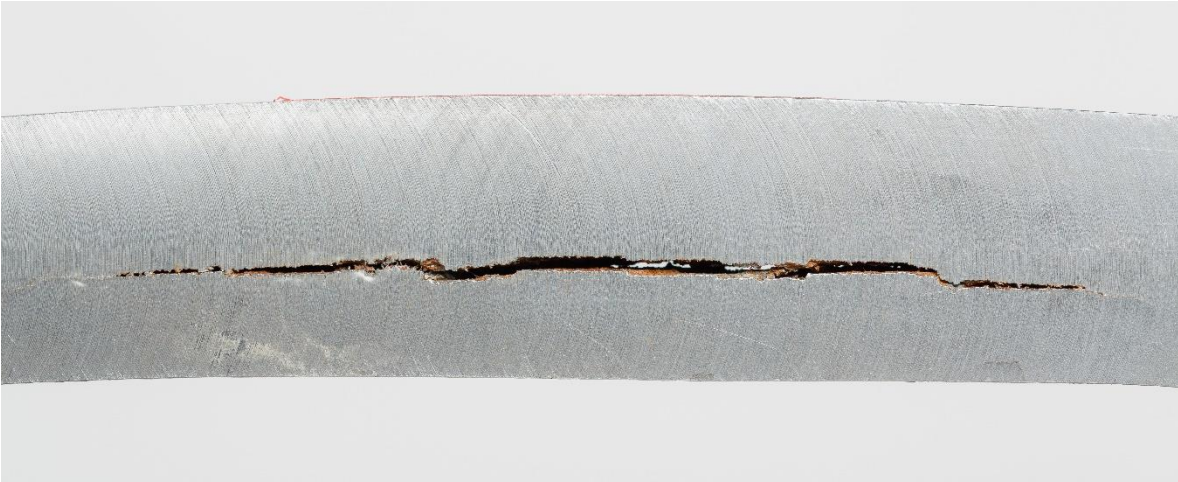
Damage Mechanism: Hydrogen Embrittlement, also known as Hydrogen Induced Cracking (HIC) ©  
**CEphoto, Uwe Aranas**

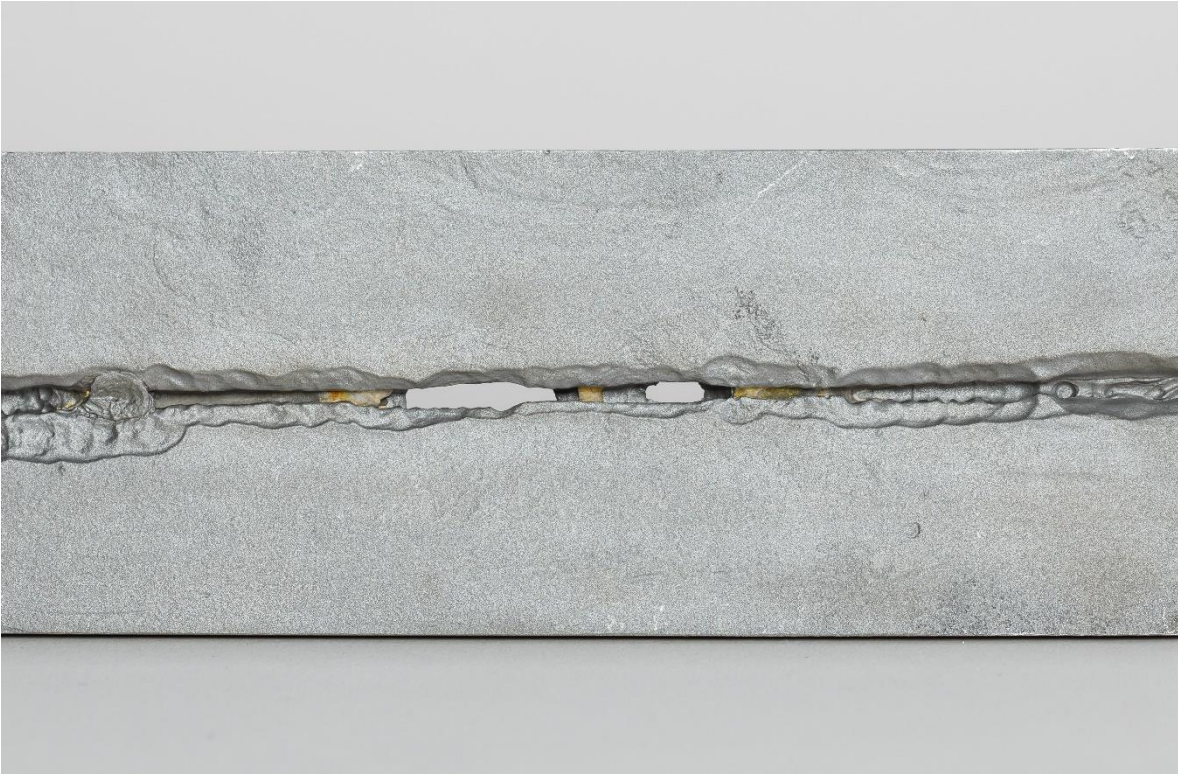
Damage mechanism: Acid corrosion in a flue gas duct as a result of condensation of flue gas. The acid accumulated behind the chamotte layer and caused the depicted corrosion. This photo: gas side of the duct © **CEphoto, Uwe Aranas**

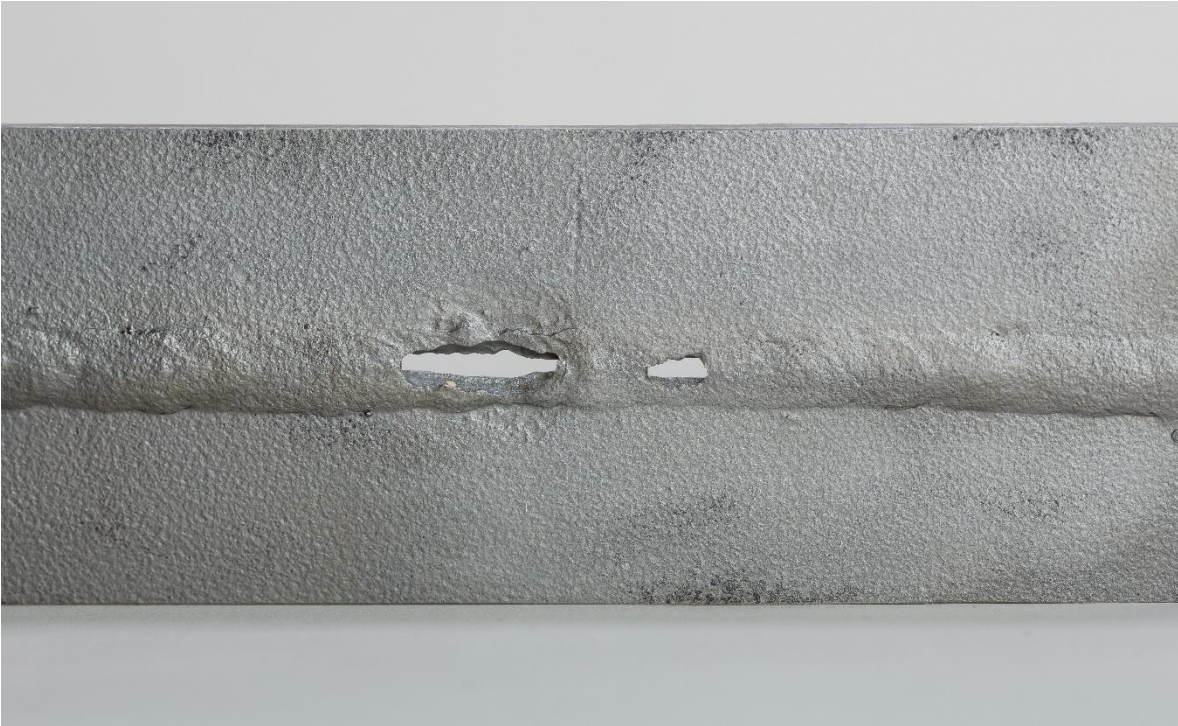
Damage mechanism: Acid corrosion in a flue gas duct as a result of condensation of flue gas. The acid accumulated behind the chamotte layer and caused the depicted corrosion. This photo:  
Atmosphere side of the duct © **CEphoto, Uwe Aranas**

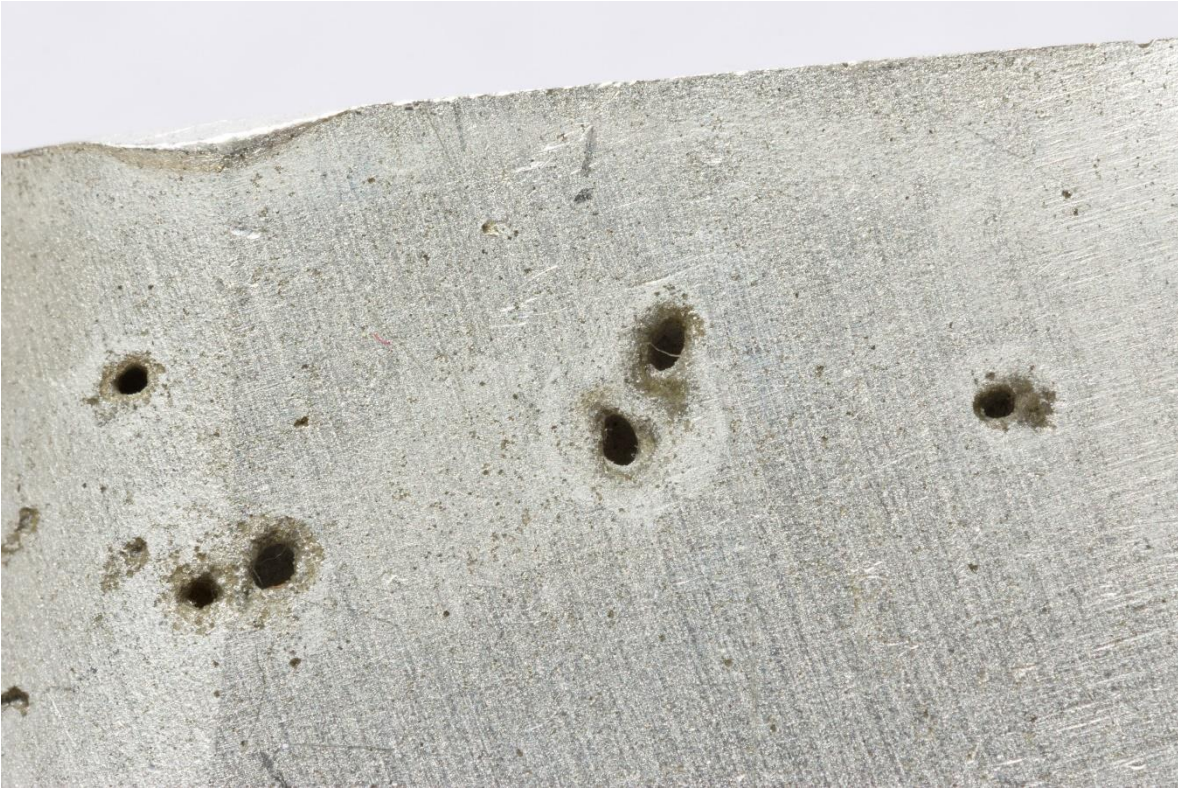
Damage mode: Pitting corrosion in a piece of aluminium. The holes caused by pitting which can be observed in this image are about 1 mm in diameter © **CEphoto, Carlos Delgado**

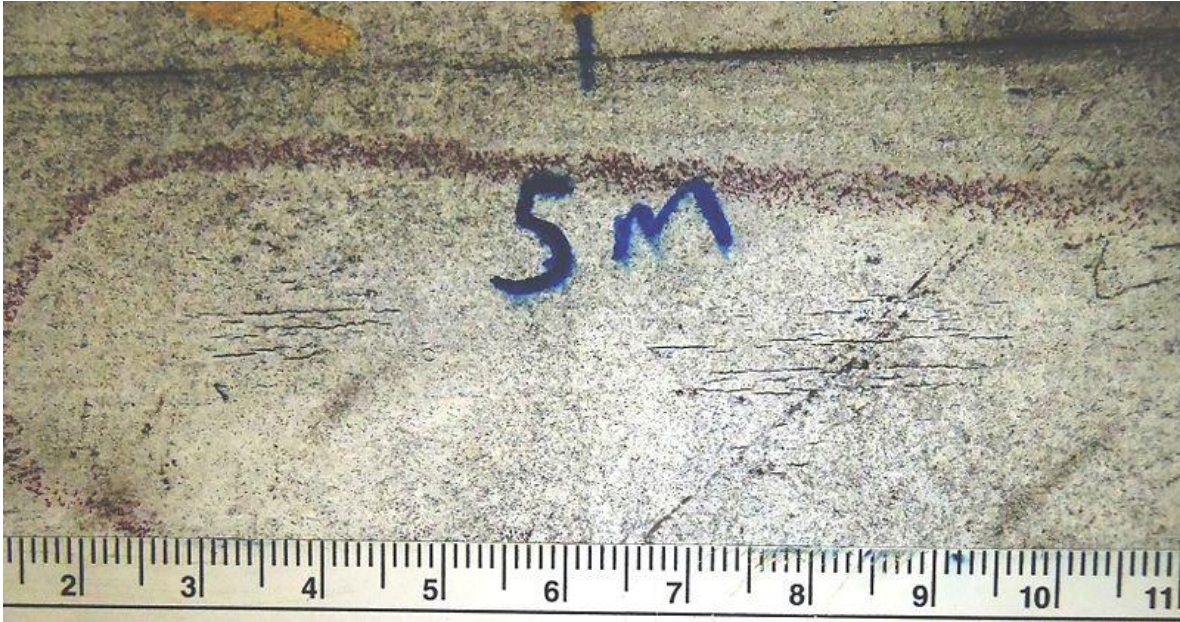
A close-up view of the surface of a pipeline showing indications of DM [stress corrosion cracking](#) (two clusters of small black lines), as revealed by [magnetic particle inspection \(MPI\)](#). The surface was prepared with white contrast paint, and magnetic particles in a liquid suspension were sprayed onto the surface while it was magnetized. Cracks which would normally have been invisible are detectable due to the magnetic particles clustering at the crack openings. The scale at the bottom of the picture is in millimeters. Markings on the pipe were made by a technician for position reference.

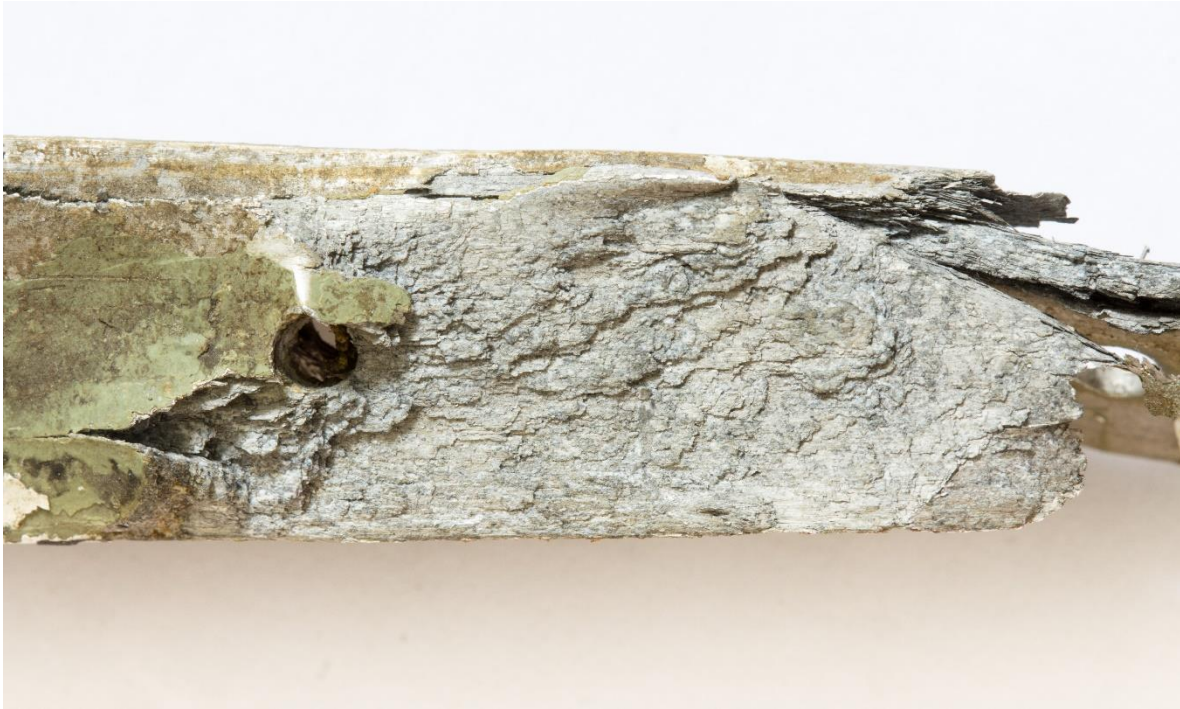
Corrosión por exfoliación en una pieza de aluminio. La pieza mide unos 14 mm de ancho. La corrosión por exfoliación es un tipo de corrosión intergranular que avanza a lo largo de los planos de cristalización, lo que da lugar a la separación del material con un aspecto de capas. ©

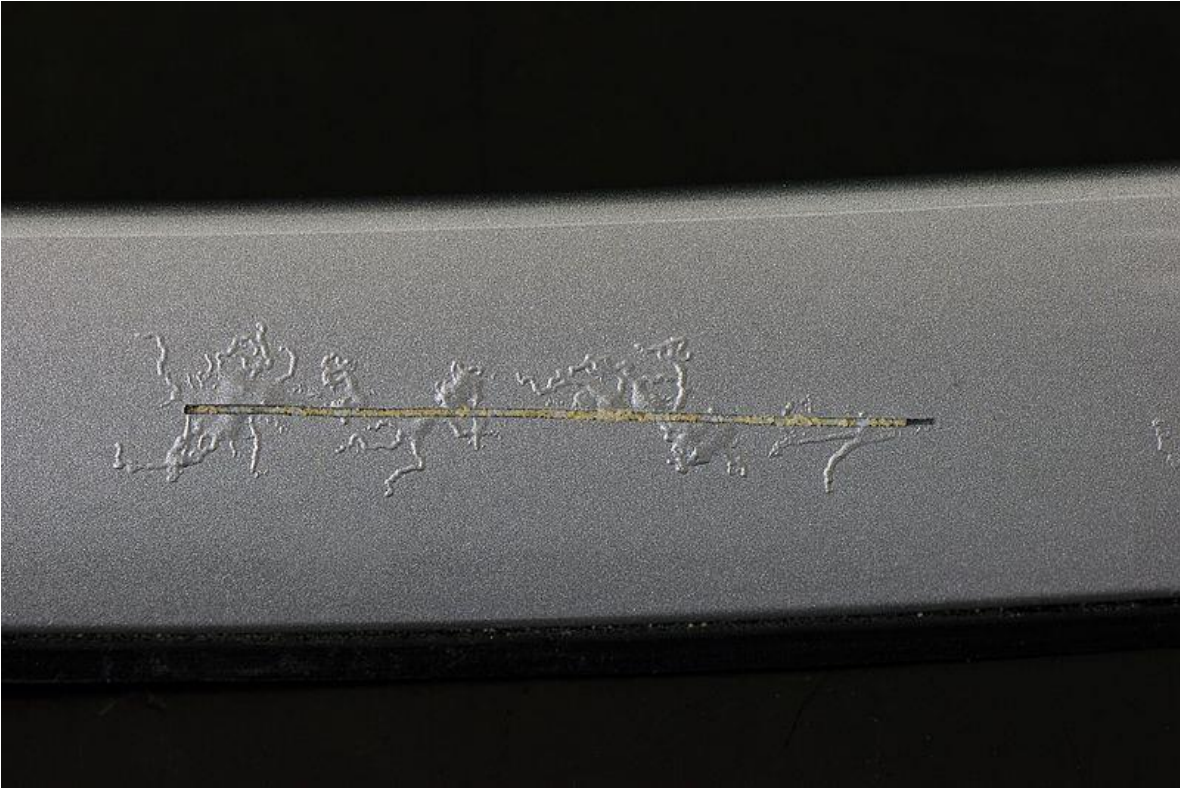
Filiform corrosion spreading from scribe on painted aluminum after complete accelerated corrosion testing (ACT version 2) CC by Matador

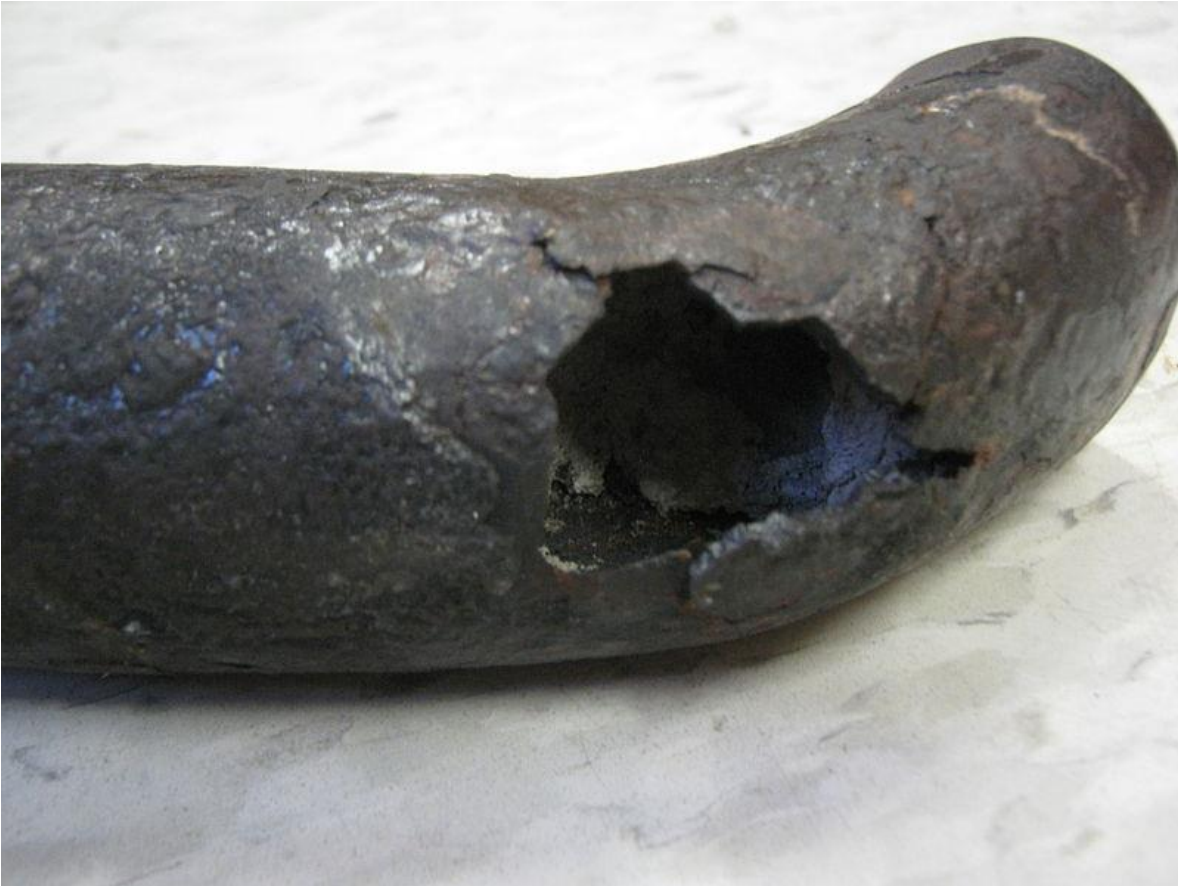
A tube damaged by DM caustic embrittlement. White caustic deposits can be seen inside. CC 1e4cMET
