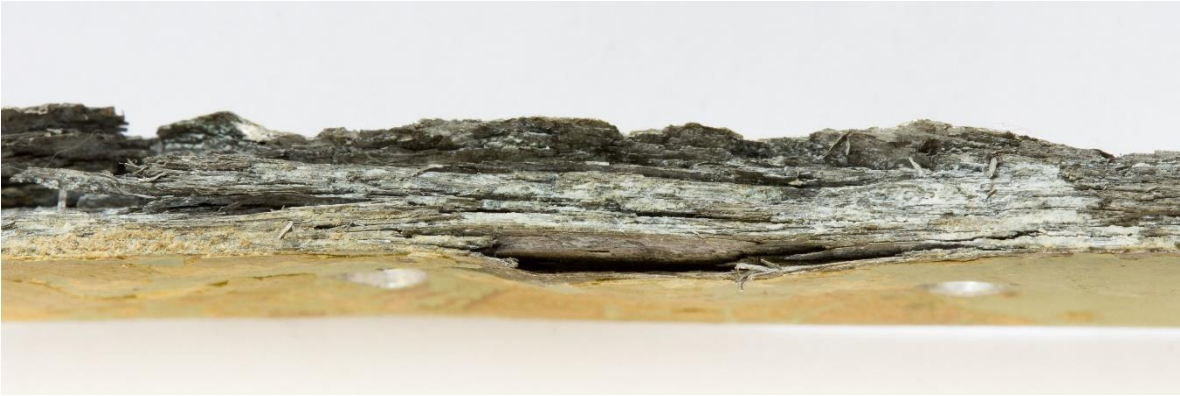
Damage mode: Pitting corrosion in a piece of aluminium. The holes caused by pitting which can be observed in this image are about 1 mm in diameter © **CEphoto, Carlos Delgado**
